Hylebos Marsh and Wildlife Habitat Restoration

Project Concept Plan

March 1997

This document was prepared by the staff of the City of Tacoma Public Works Department, Utility Services Engineering Division. Questions concerning the information presented can be directed to Greg Zentner of Utility Services Engineering at the following address and phone number.

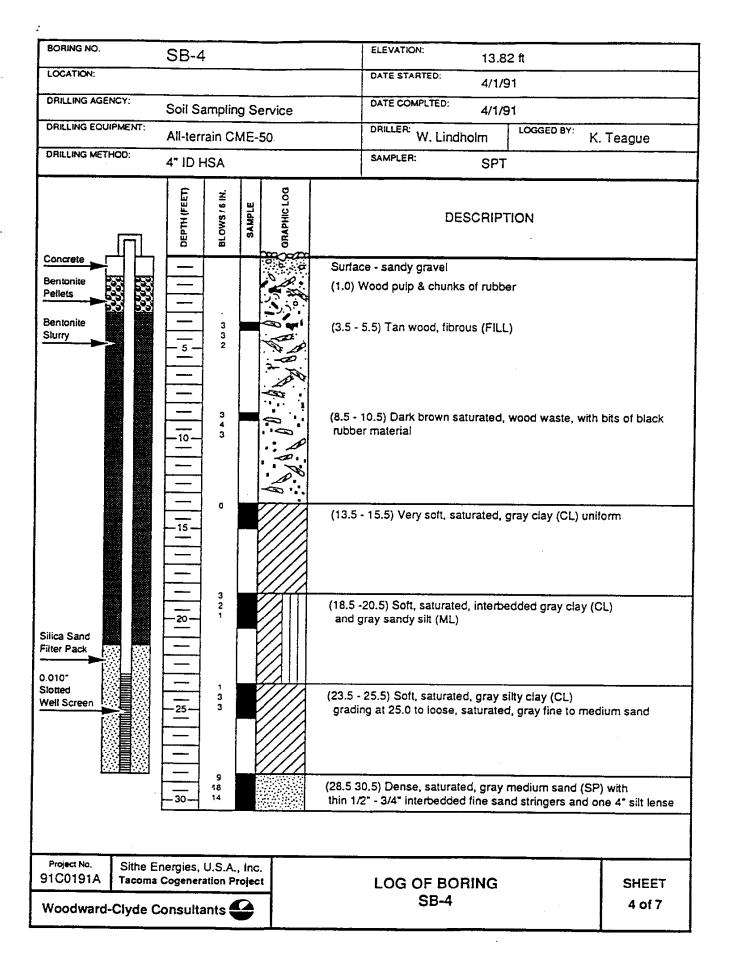
BORING NO.	SB-3				ELEVATION:	14.0	7 ft	
LOCATION:					DATE STARTED:	3/29	/91	
DRILLING AGENCY:	Soil Sam	pling S	ervice		DATE COMPLTED:	3/29/	91	
DRILLING EQUIPMENT:	All-terrain	n CME-	50		DRILLER: W. Line	dhoim	LOGGED BY:	(. Teague
DRILLING METHOD:	4" ID HS	A			SAMPLER:	SPT		
	DEPTH (FEET)	BLOWS/6 IN.	GRAPHIC LOG		D	ESCRIPT	ION	
Bentonite Chips (Enviroplug Medium)	5	4 6 8	o O	powd (3.5 -	e: Coarse sandy ery lime 5.5) Loose to med of fine sand (FILL)	ium, dense		
	1-10	1/2		(8.5 - 1 gray ve	0.5) Very soft, sat entically oriented st	turated, gra	ay-tan clay (CL)	with some darker
Select Silica Sand 10/20				in low	15.5) Very soft, sa er 3* 0.5) Very soft, sat dded with loose, s	urated gra	y clay (2 layers, 4	4" and 7" thick\

0.010° Slotted Well Screen				with tra	25.5) Loose, satura ce of clay, grading th serveral white-ta	to dense.	saturated, gray,	r fine sand (SW) medium sand
Project No. Sithe Er 91C0191A Tacoma	nergies, U.S Cogeneration	.A., Inc. Projec			LOG OF BO	RING		SHEET
Woodward-Clyde C	onsultants	•	7		SB-3			3 of 7
