U.S. et al. v. Beazer East, Inc.
Consent Decree Appendix A
Drayton Hall Restoration Project Statement of Work

**BEAZER EAST, INC
FORMER KOPPERS SITE
CHARLESTON, SOUTH CAROLINA**

**DRAYTON HALL RESTORATION PROJECT STATEMENT OF
WORK**

**FINAL
MAY 2018**

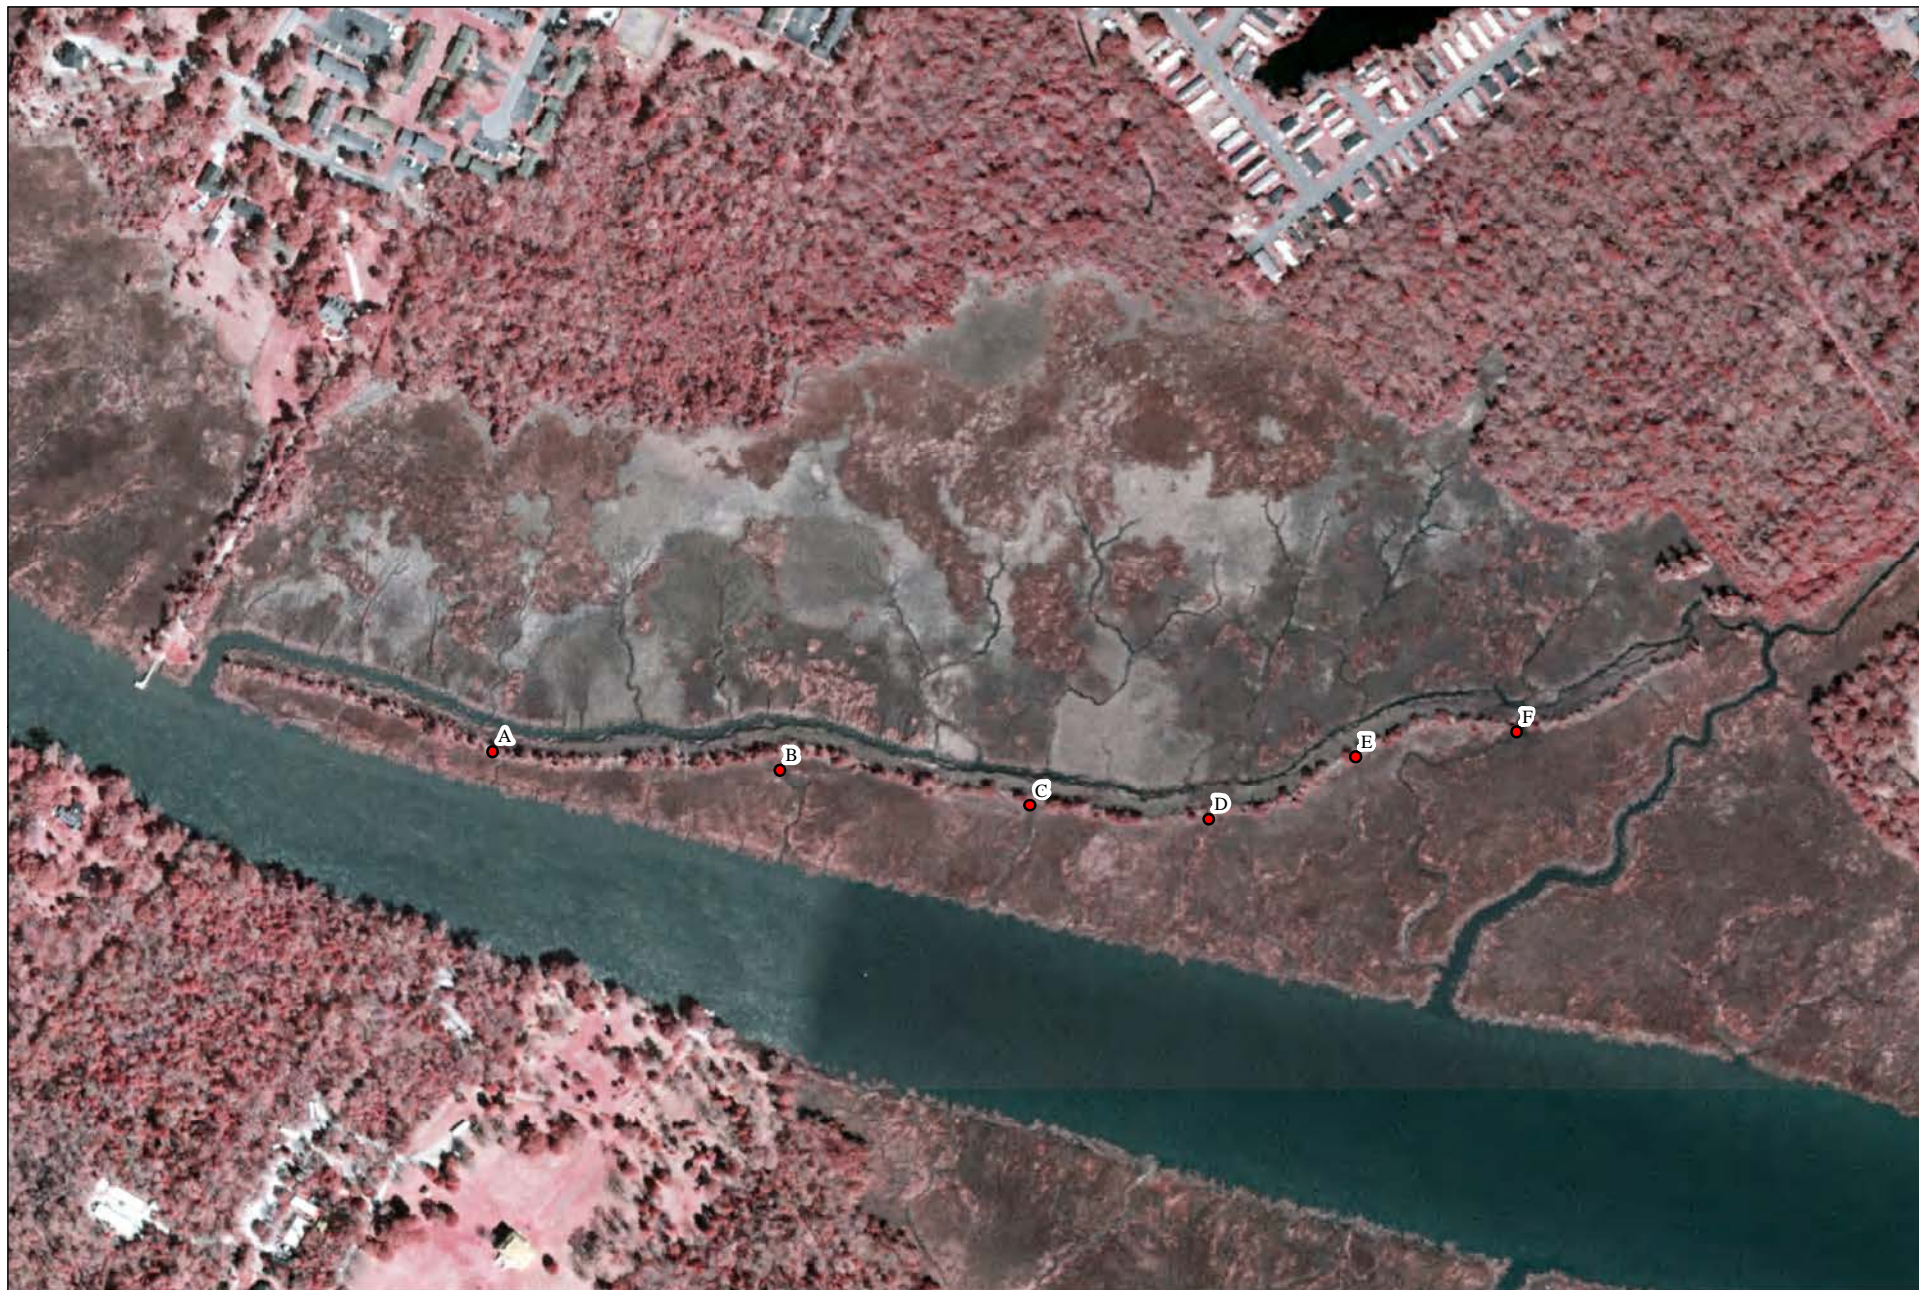
**FIGURE 2 - 2006 INFRARED AERIAL PHOTO
 BEAZER - NRDA STRATEGY UPDATE
 CHARLESTON COUNTY, SC**

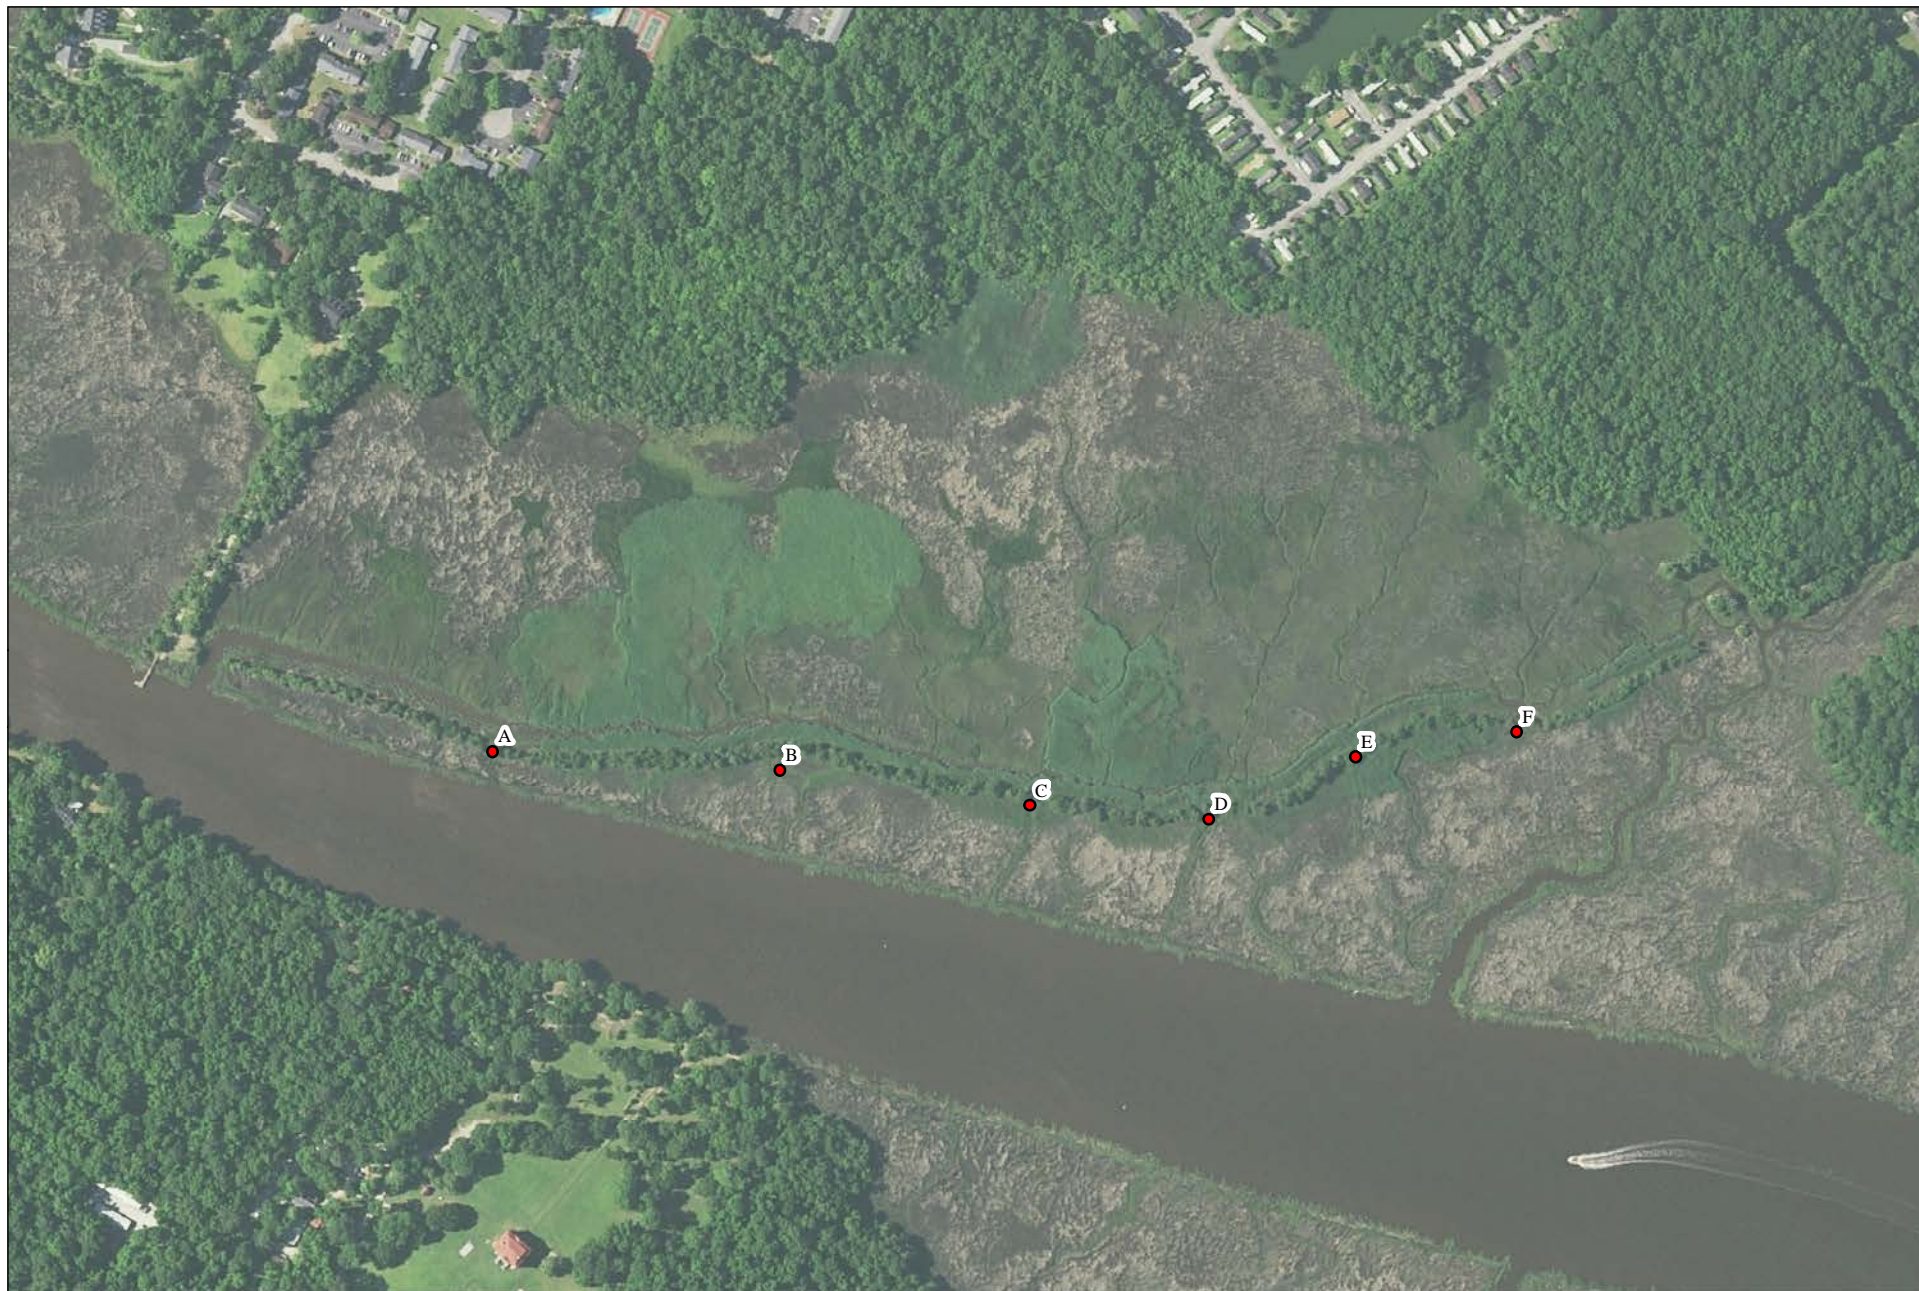
**FIGURE 4 - 2015 TRUE COLOR AERIAL PHOTO
BEAZER - NRDA STRATEGY UPDATE
CHARLESTON COUNTY, SC**

A total of five new breaches (points A, B, C, D, and E) will be created in the dike (Figure 4). To construct the dike breaches, a barge-mounted or amphibious track hoe will enter the impoundment from the western end and travel in the dredged canal. The track hoe will travel to the location of proposed Breach A and begin excavation. The dike will be dug out fifteen to twenty feet wide with side slopes of approximately 3:1, and down to an elevation slightly above the surrounding marsh. The track hoe will then stand on the excavated dike area and reach into the historical channel between the Ashley River and the dike. A shallow excavation of the channel will be made out as far as the track hoe will reach. All spoil will be placed on the dike. The track hoe will then move back into the inside of the impoundment and dig the remaining portion of the dike out to an elevation approximately three feet below the surface of the marsh. The interior shelf will be breached to connect the inside dredged canal with the new dike breach. Figure 5 shows a typical completed dike breach detail. The track hoe will then move east to the site of the next proposed breach.
